New York State Department of Transportation

Yellow Flag NB2258W006

Location: Span 210, Stringer S2 at Pier 210 over 3rd Avenue Eastbound.

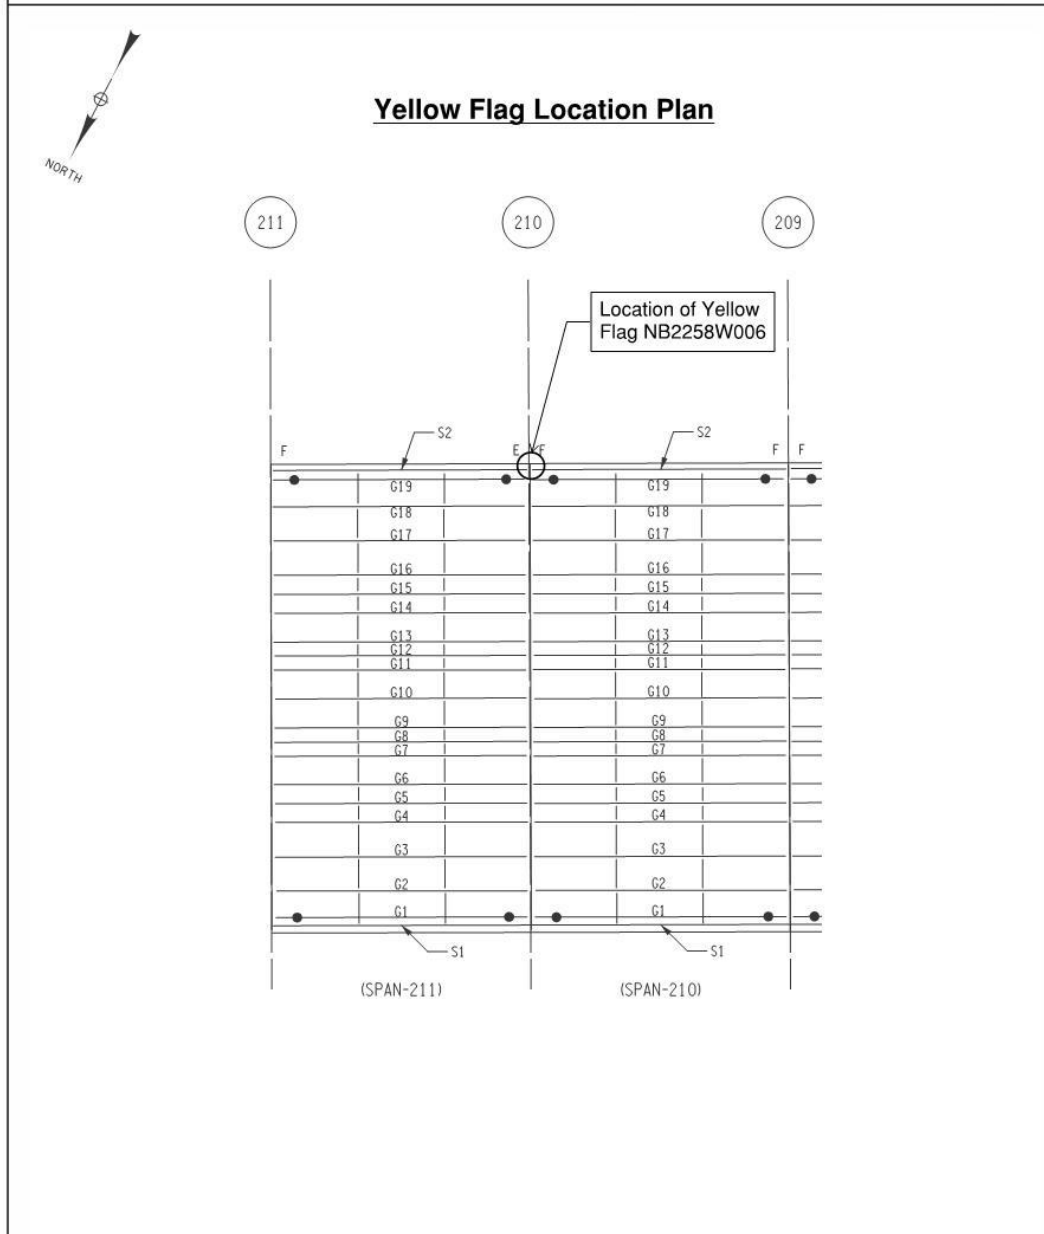
Flag PhotographsPhoto Number: **1**Photo Filename: **22_Flag Location Plan.jpg**Gowanus Expressway
2022 Biennial Inspection - Field SketchBIN: 1065318Team: AA/TSDate: 07/18/2022Span: 210Location: Stringer S2 at Pier 210

**wsp****Attachment Description: Yellow Flag Location Plan**

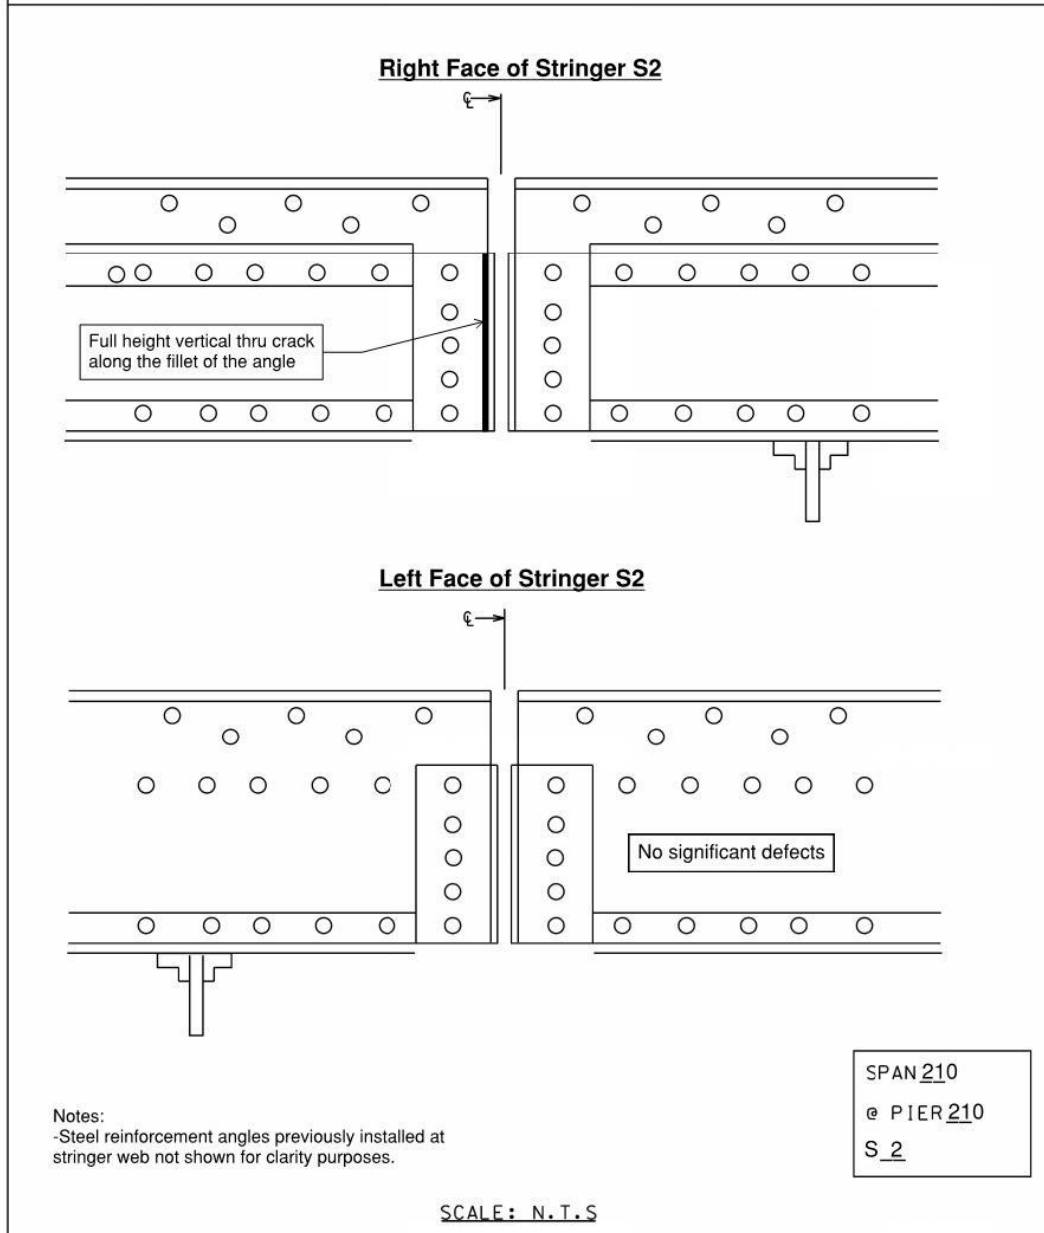
Photo Number: 2

Description: The right connection angle at Stringer S2 in Span 210 at Pier 210 exhibits a full height vertical thru crack in the fillet of the connection angle (Photo 5). The left side connection angle exhibits no significant defects. The stringer end at the pier has previously installed steel reinforcement angles which exhibit no significant defects and the stringer bottom flange is connected to the pier top flange with no significant defects at the connection (Photos 4 and 6). Refer to the Yellow Flag Condition Sketch (Photo 2) for more details.

Attachment Description: Yellow Flag Condition Sketch

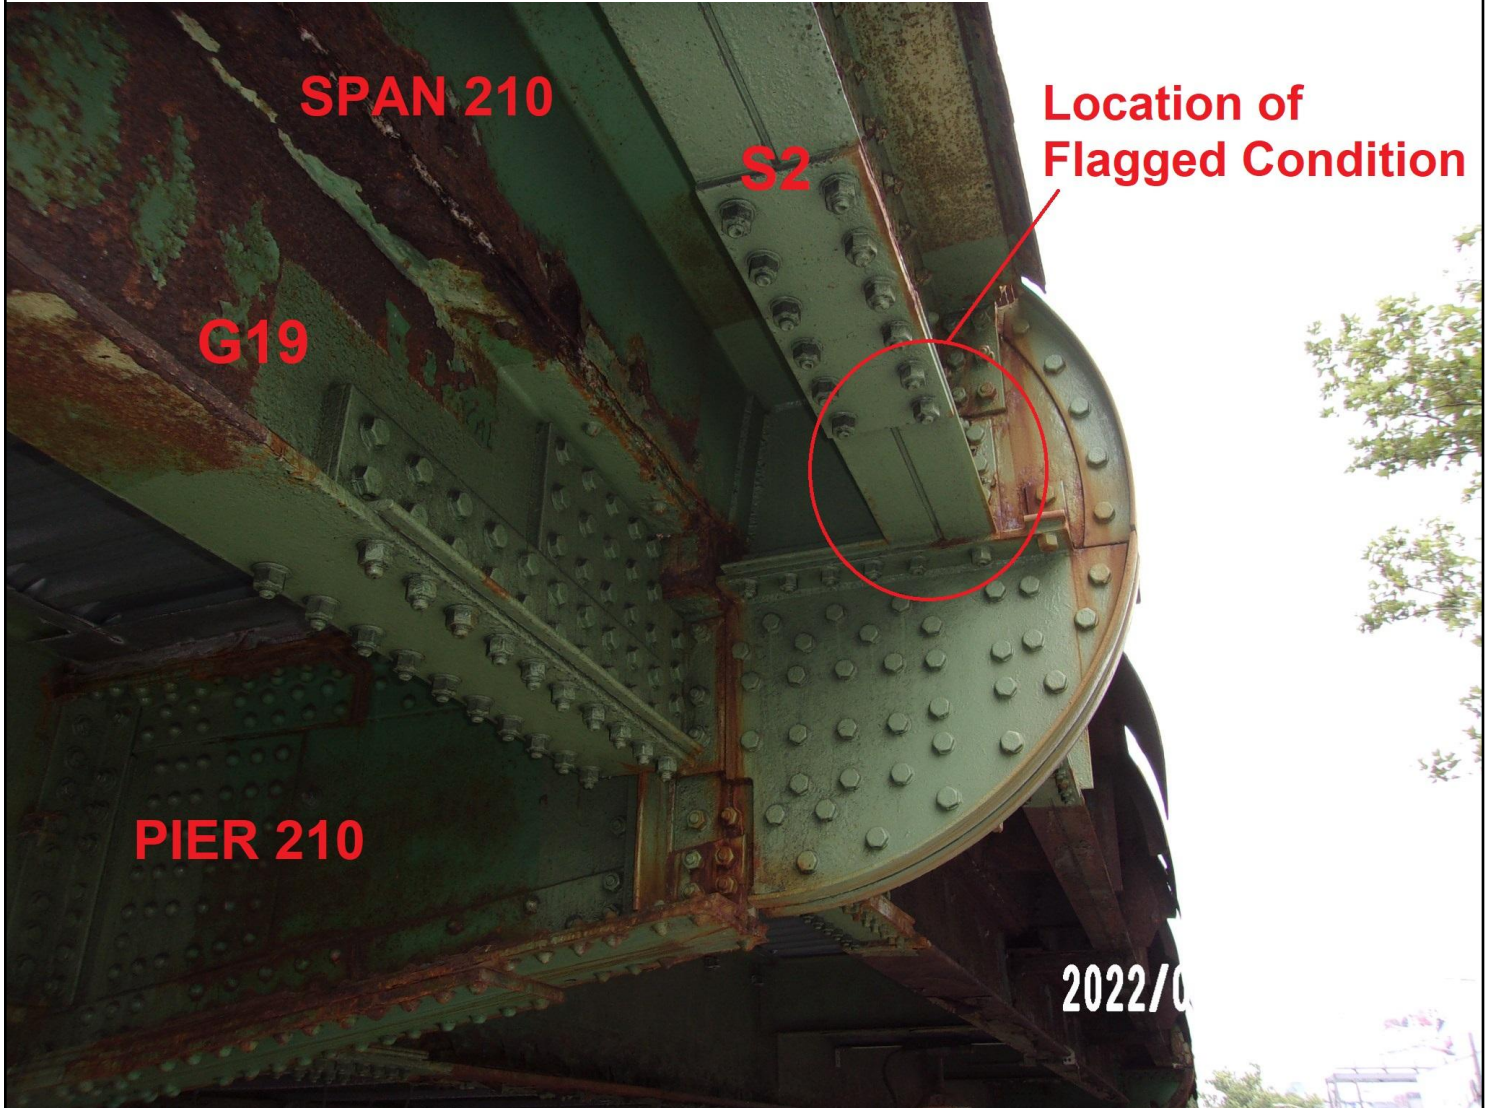
Photo Number: 3

Attachment Description: General view of the flagged condition at Stringer S2 in Span 210 at Pier 210. Looking End.

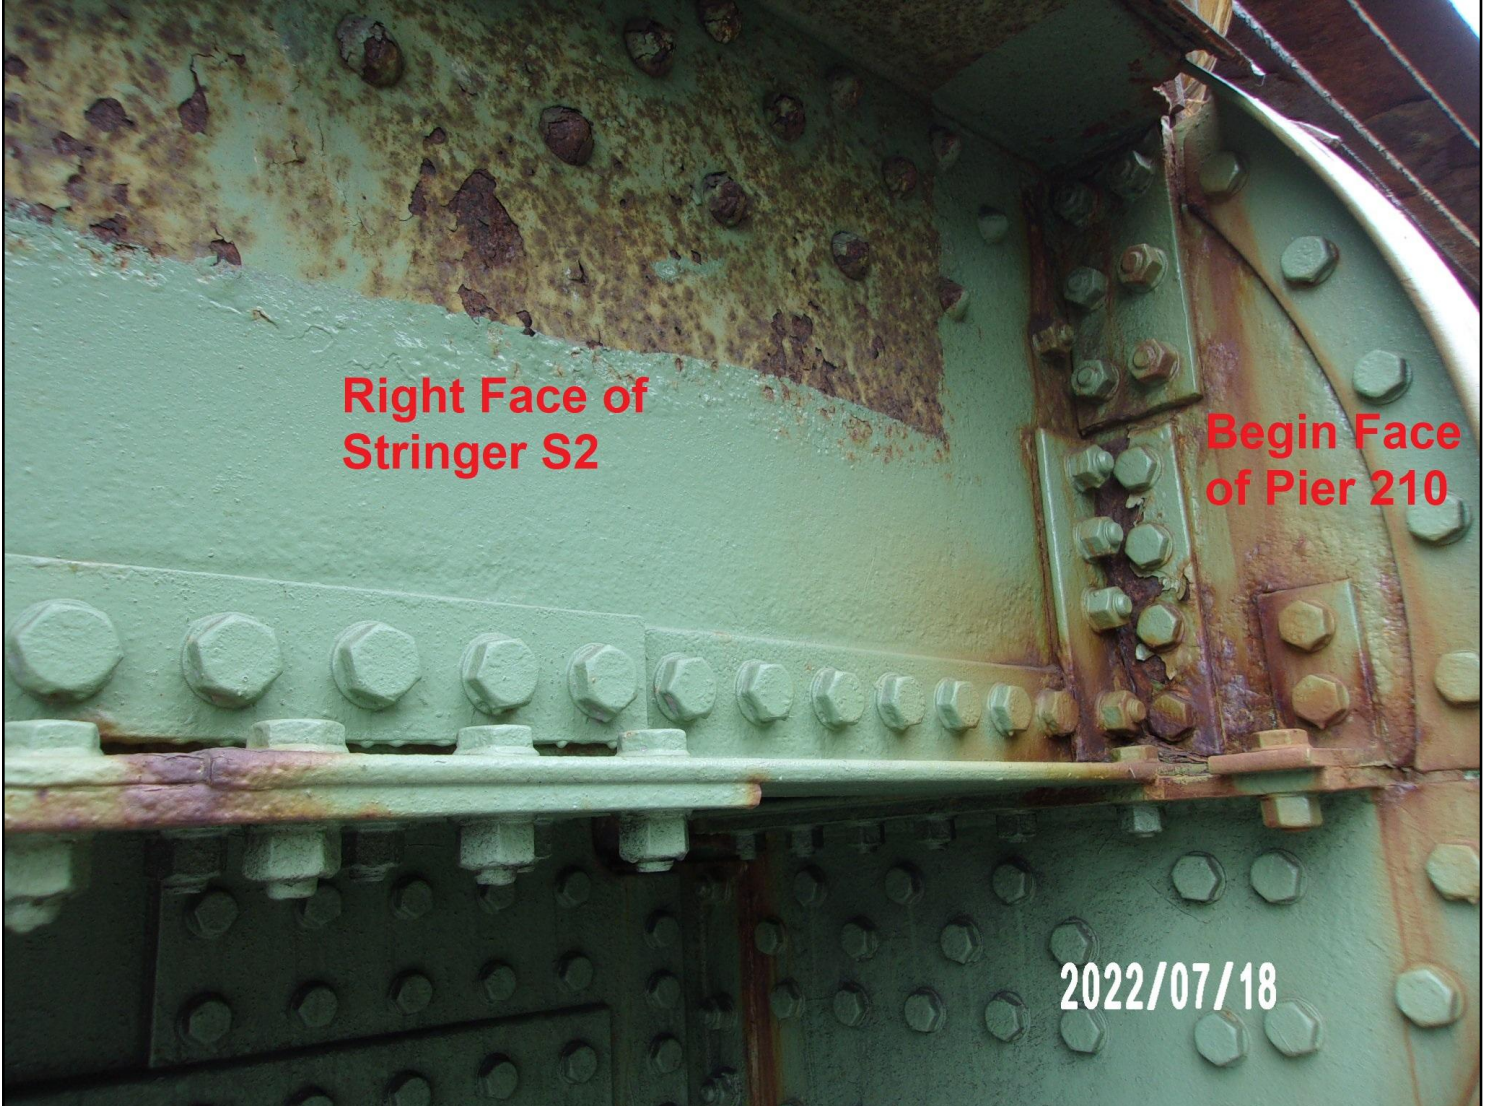
Photo Number: 4

Attachment Description: General view of the right face of Stringer S2 in Span 210 at Pier 210 where the right connection angle exhibits a full height vertical thru crack along the fillet of the angle (See also Photo No.5). Looking End and Left.

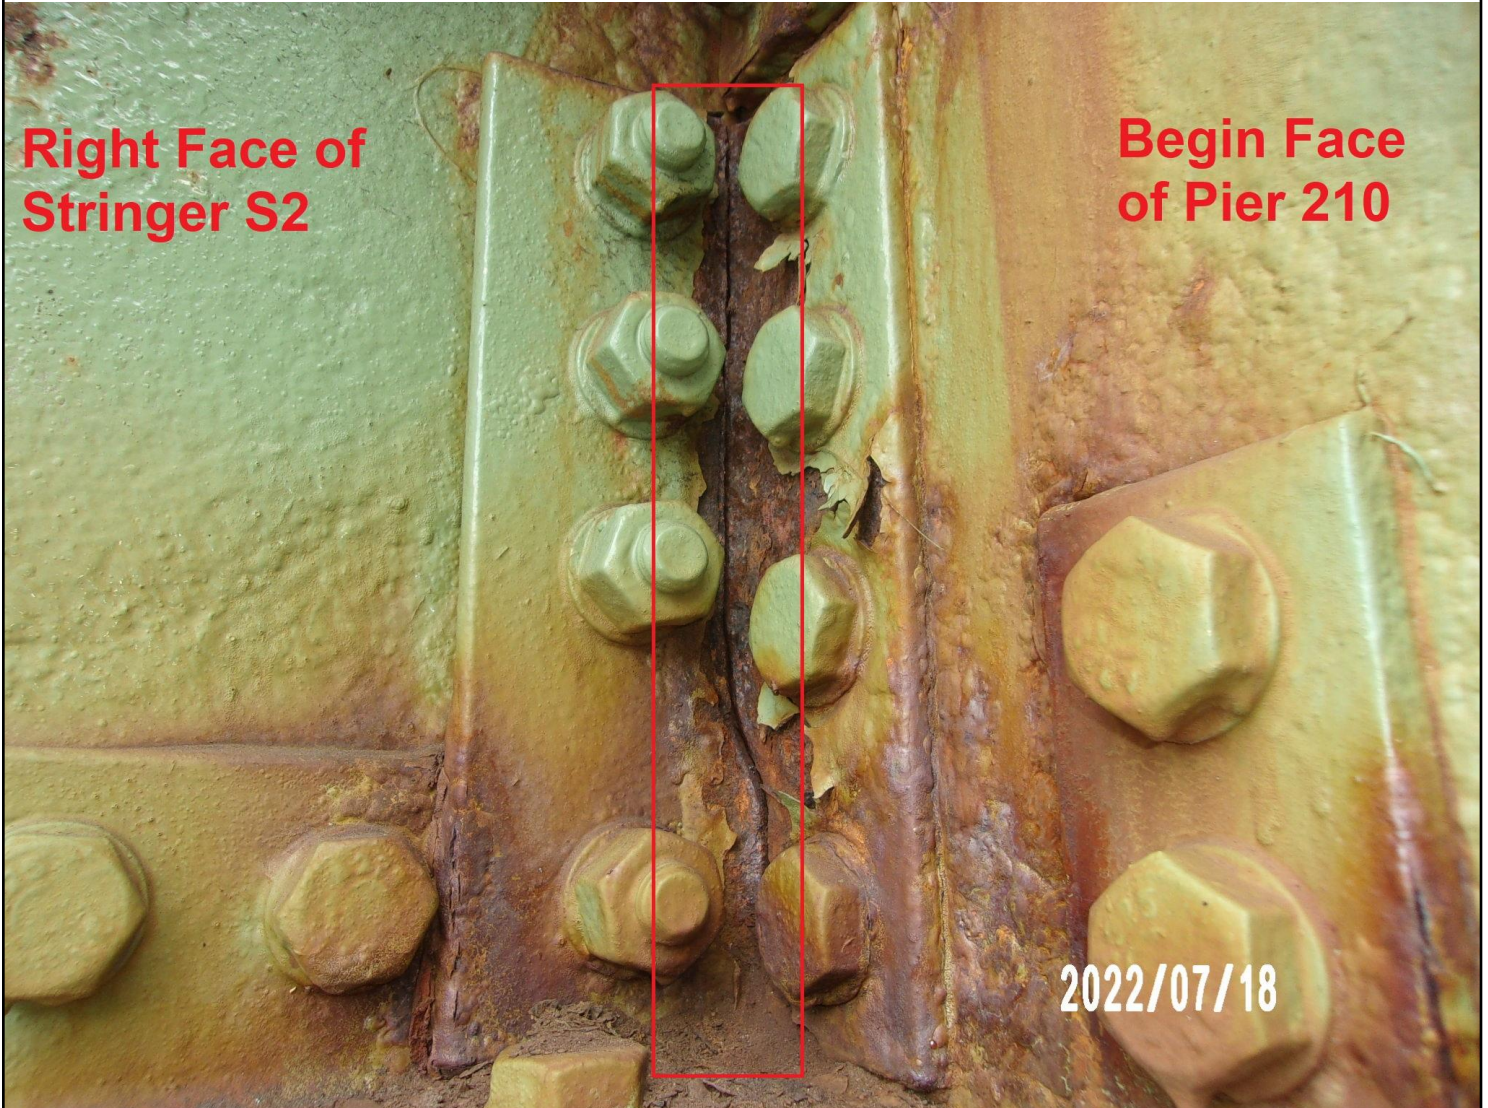
Photo Number: 5

Attachment Description: The right face of Stringer S2 in Span 210 at Pier 210. The right connection angle exhibits full height vertical thru crack along the fillet of the angle. Looking End and Left.

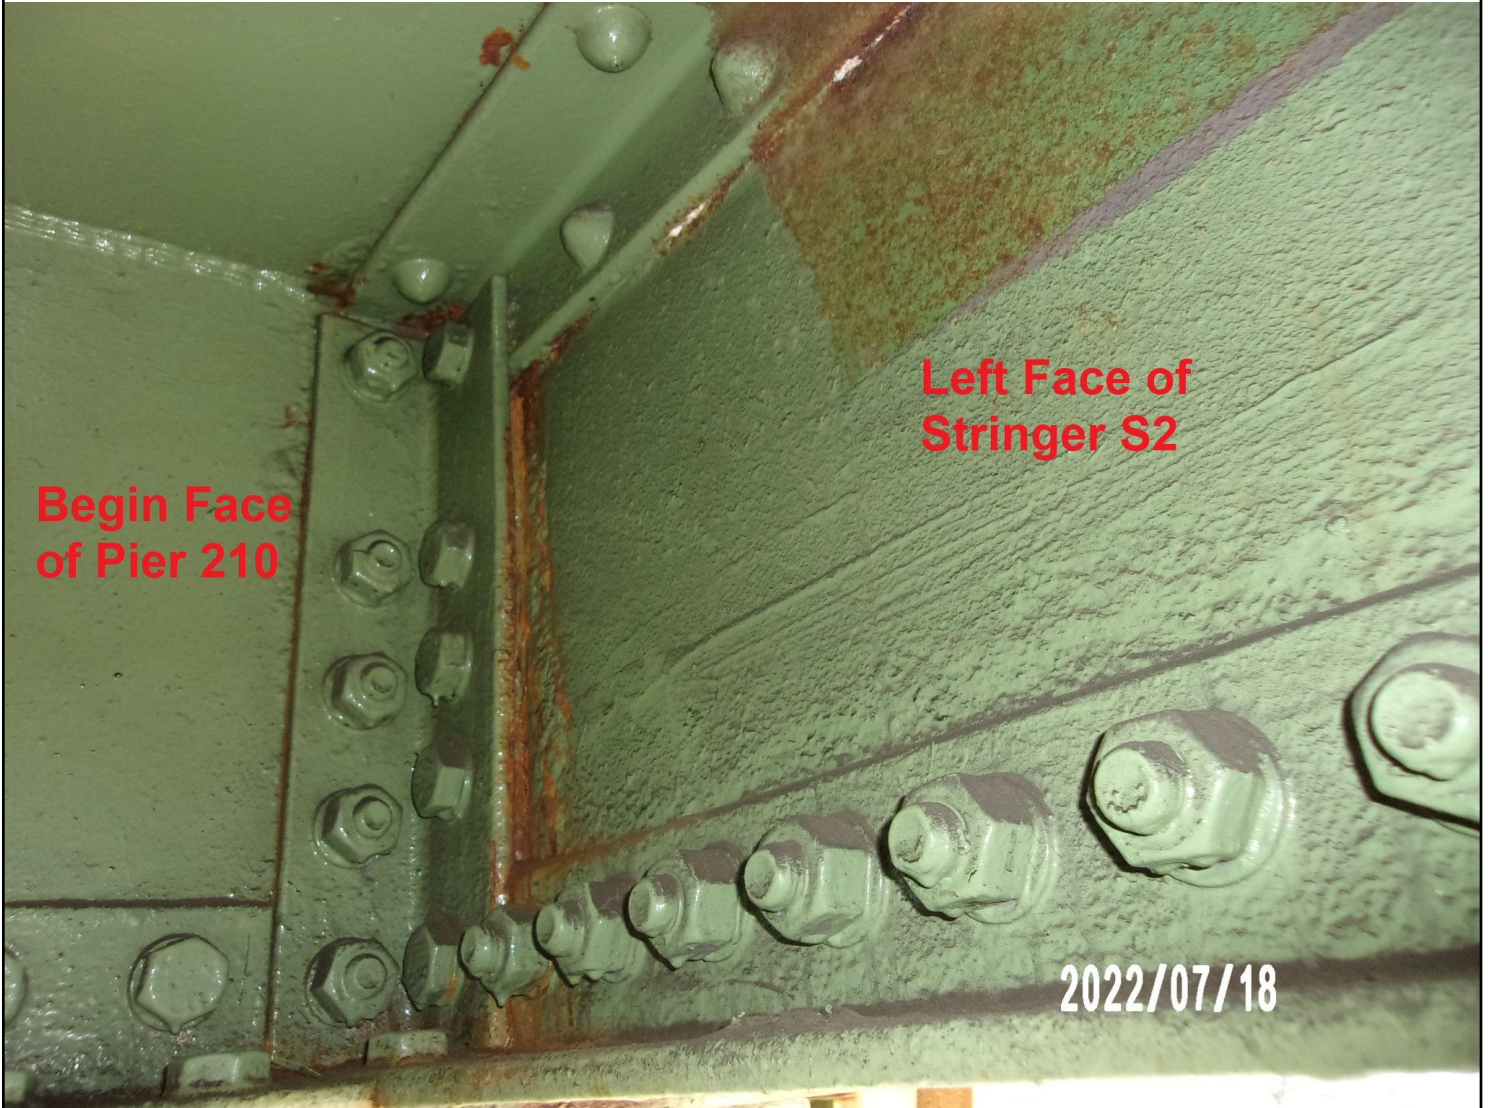
Photo Number: 6

Attachment Description: The left face of Stringer S2 in Span 210 at Pier 210. The left connection angle at the stringer exhibits no significant defects. Looking End and Right.
